SCHILLER POND DAM

NJ 00153

PHASE 1 INSPECTION REPORT NATIONAL DAM SAFETY PROGRAM

MAY 1981

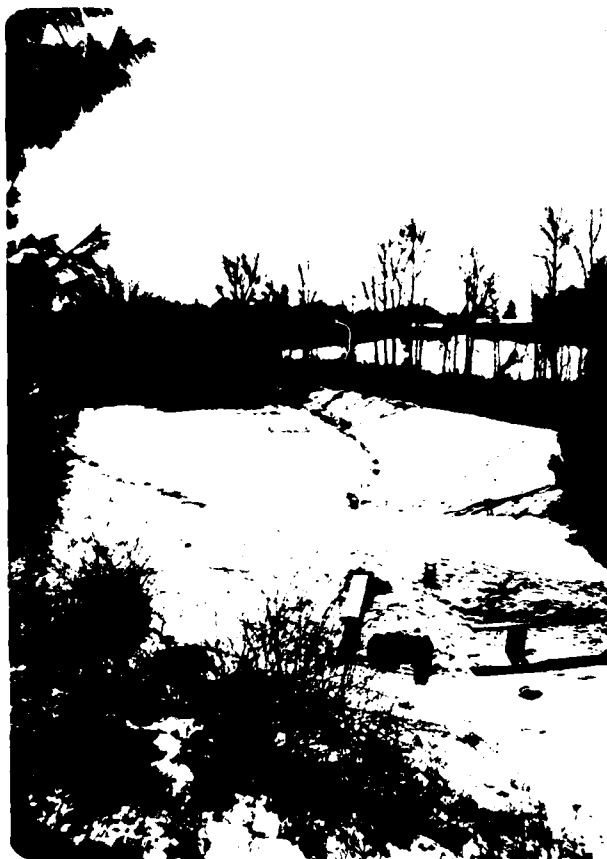
There are no signs of distress in the embankment of the Schiller Pond Dam. The trees growing on the embankment at the junction with the auxiliary spillway could pose a threat to stability. The spillways are in good condition.

Photo 1 - View of dam taken from right bank of auxiliary spillway. Note clump of trees on embankment in right of photo. (Photo taken on January 13, 1961.)

3. The trees should be removed from the embankment slopes to avoid problems that may develop from roots. The area should then be seeded to develop a growth of grass for surface erosion protection. This should be done within twelve months.
4. Determine if the low-level outlet gate is operable, and if not institute remedial action to make it operable within twelve months.
5. The owner should develop an emergency action plan (if one is not already available) outlining actions to be taken by the operator to minimize downstream effects of an emergency and establish a flood warning system for the downstream communities within three months.

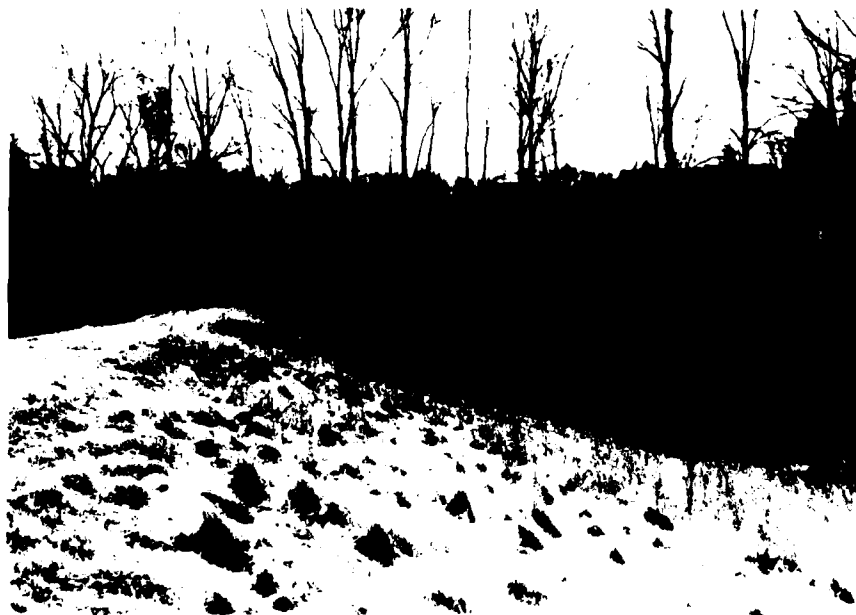
Photo 3 - View of downstream slope looking towards left
end of dam. Note low-level outlet pipe in the
lower right. (Photo taken on February 3, 1981.)
